# Cultural Historic and Archaeological Documentation of JFL-502, Rowan Street, at the Intersection of Rowan and 11<sup>th</sup> Streets, Louisville, Jefferson County, Kentucky

PROJECT NO. PR18008 • CULTURAL RESOURCES REPORT TR21009

KHC Project No. FY17-2636

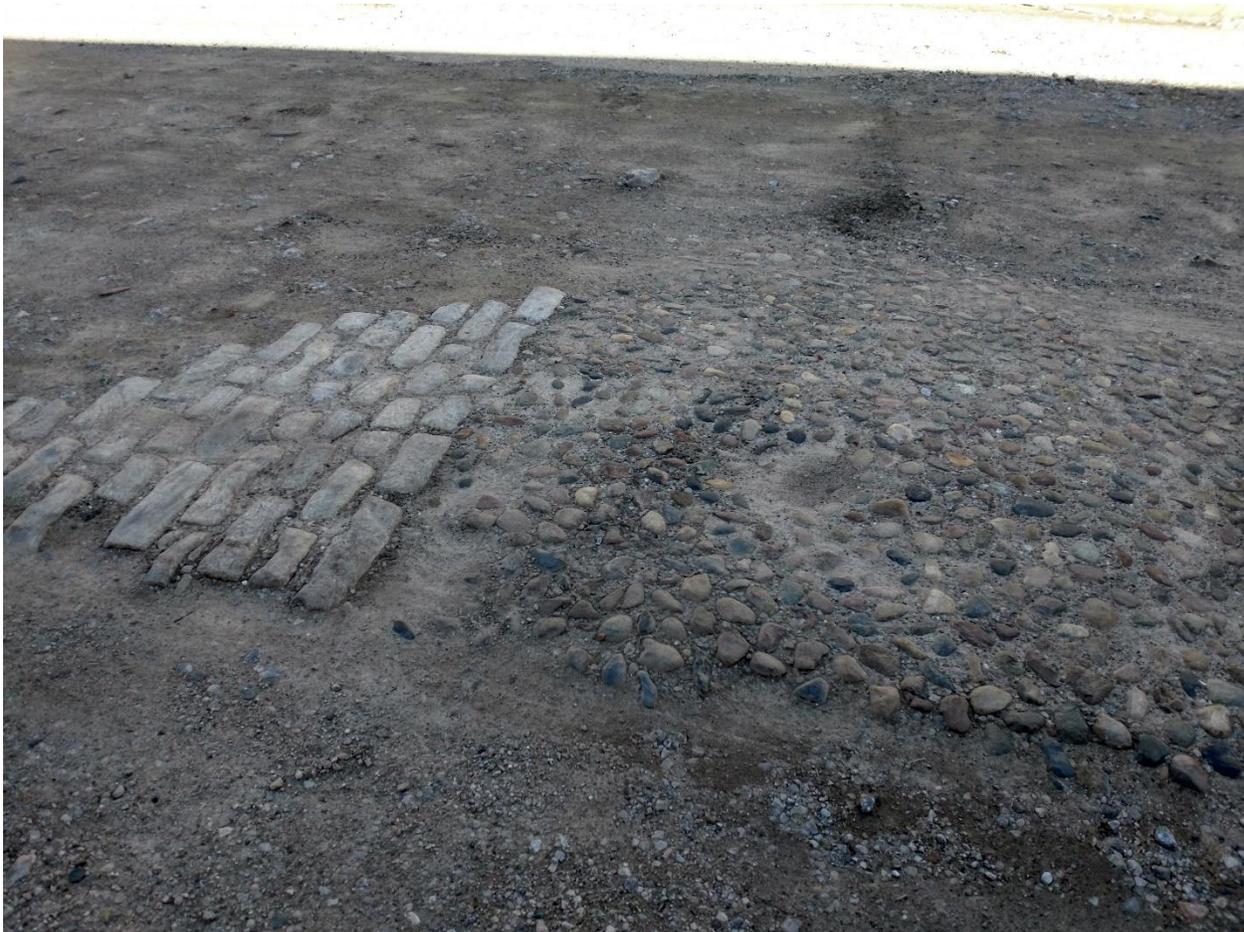
**Figure 48. Image of former road surface of Northwestern Parkway in Louisville that shows transition from cobblestone to boulder block paving.**

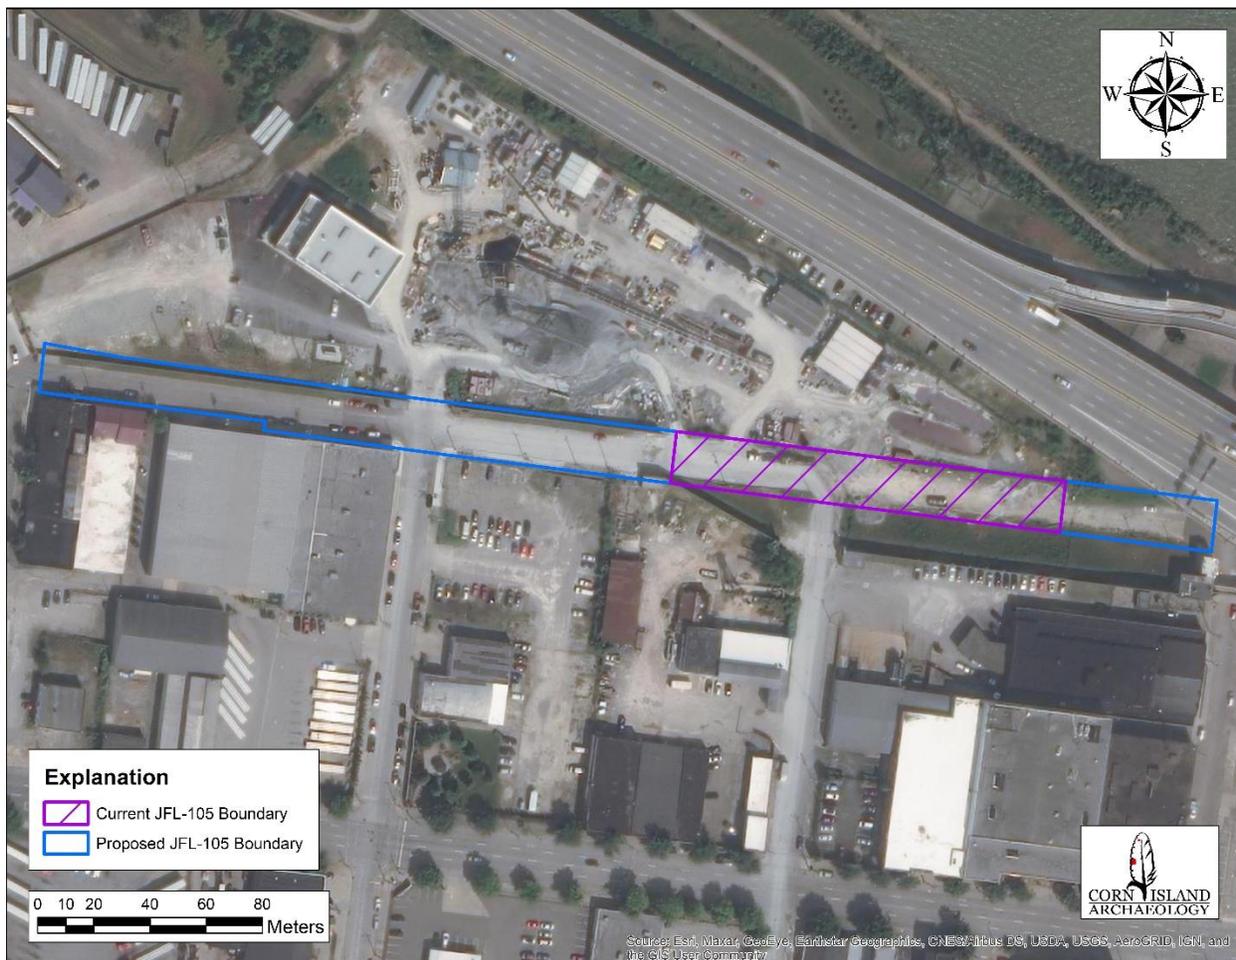
**Figure 59. Map showing current and proposed boundaries of JFL-502.**

The currently recorded resource known as JFL-502 consists of an exposed granite boulder block road surface that extends from 10<sup>th</sup> to 11<sup>th</sup> streets along Rowan Street (**Figure 59**). The resource was originally thought to only include the exposed segment of roadbed. However, the resource is now known to have extended two additional blocks to 13<sup>th</sup> Street. The historic road surface between 11<sup>th</sup> and 13<sup>th</sup> streets is highly damaged, and mostly covered by modern asphalt. The roadbed of Rowan Street, between 10<sup>th</sup> and 13<sup>th</sup> streets is made up of a series of tightly laid granite blocks; however, the granite pavers between 11<sup>th</sup> and 13<sup>th</sup> streets have been covered with layers of asphalt and are only visible through holes in the modern pavement. The granite boulder block pavers that comprise this resource have rounded edges that are irregular in size and shape (**Figure 60, Figure 61, Figure 62, Figure 63, and Table 2**). They were recorded on the original KHC form as limestone but are in fact made of granite and are quite heavy. Similar blocks have been identified elsewhere in the city beneath asphalt pavement. While these pavers were once thought to have been limestone cobblestones, archaeology and research have proven that these blocks are actually made from granite and are cut blocks, not naturally shaped cobblestones. Other sources have stated these stones date from the 1700s, however, a newspaper article in the *Courier Journal* on May 19, 1883 confirm that plans called for granite paving stones to be used in this portion of Rowan Street (*Courier Journal* 1883). In addition, on September 21, 2017 Dr. Jay Stottman, who specialized in Portland archaeology and history, stated that the Portland town trustees did not pave Rowan and that Rowan Street was probably not paved with blocks until the late 1800s by the city of Louisville.

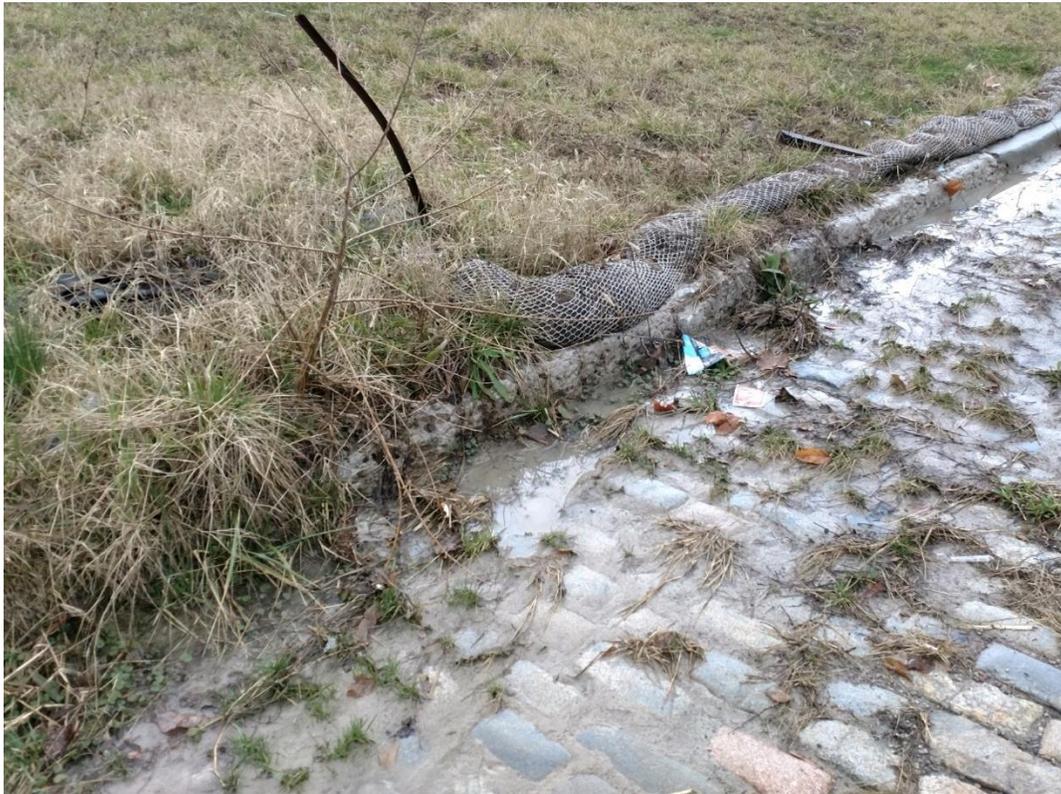
**Figure 64. Section of limestone curb between 10<sup>th</sup> and 11<sup>th</sup> streets.**

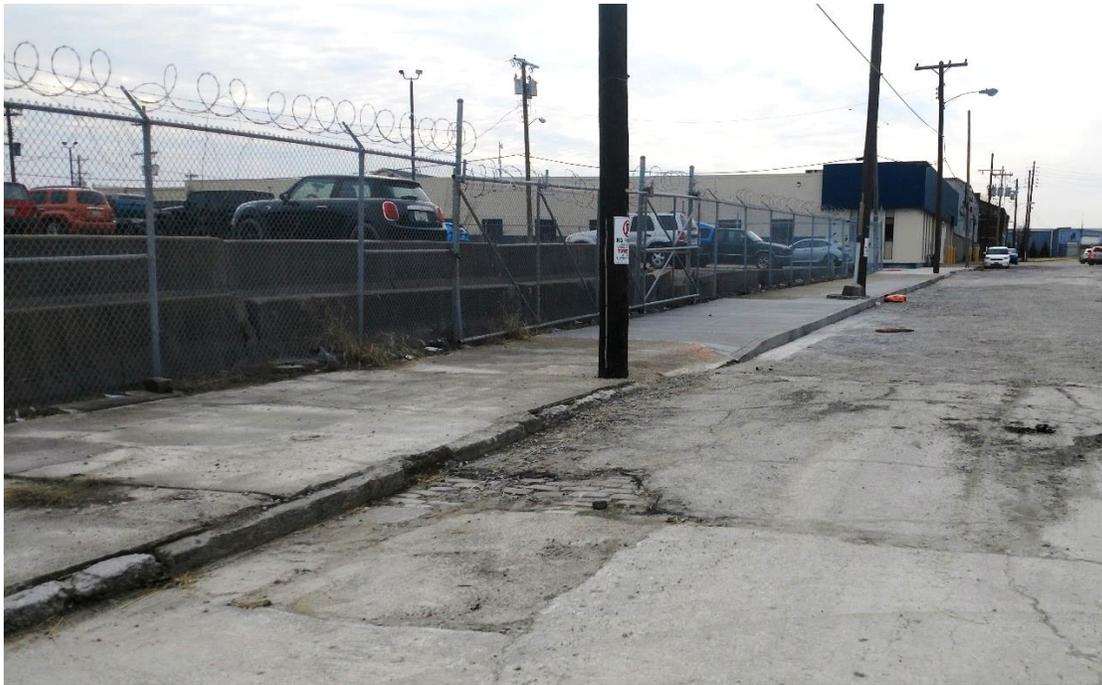
**Figure 65. Section of limestone curb on south side of Rowan between 11<sup>th</sup> and 12<sup>th</sup> streets.**

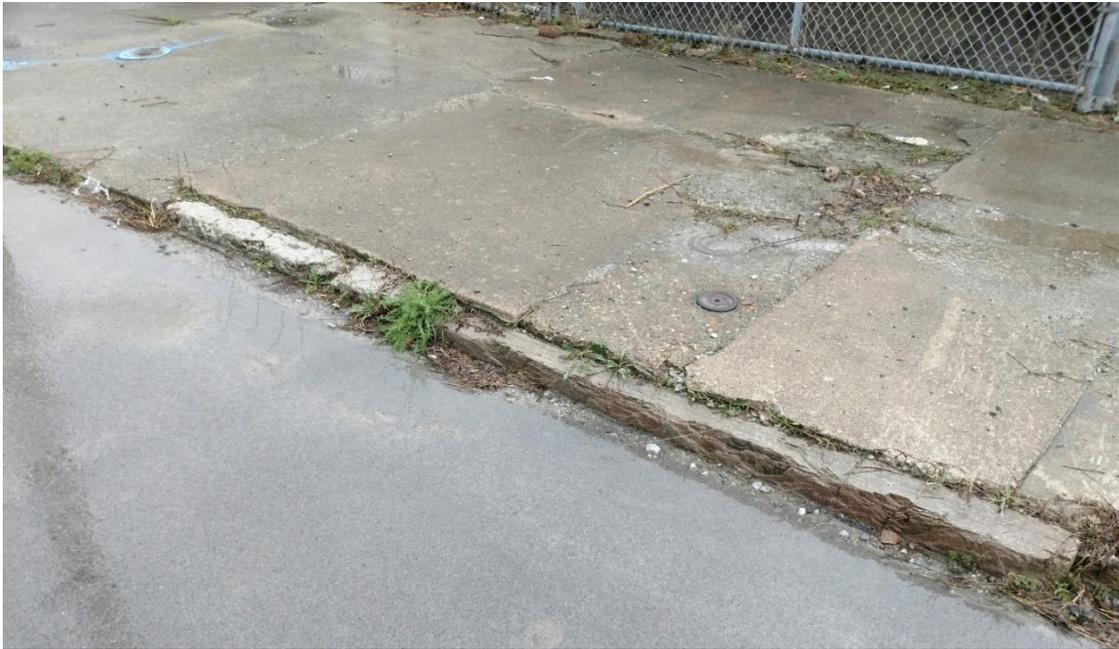
**Figure 66. Close-up of limestone curb between 11<sup>th</sup> and 13<sup>th</sup> streets.**

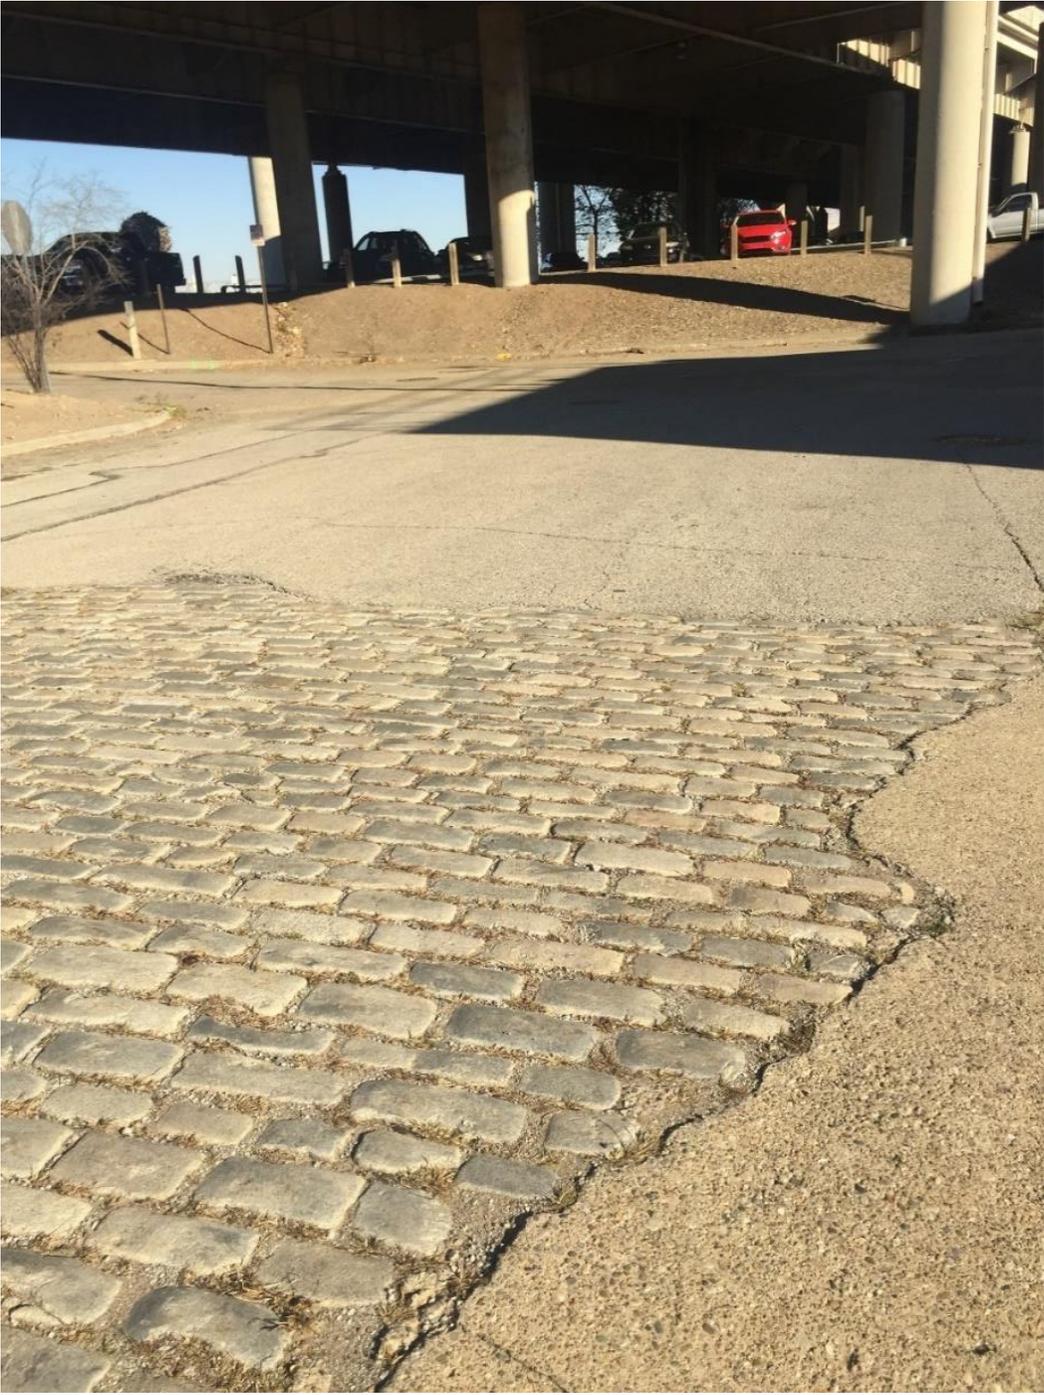
**Figure 68. Boulder blocks extending beneath asphalt paving.**

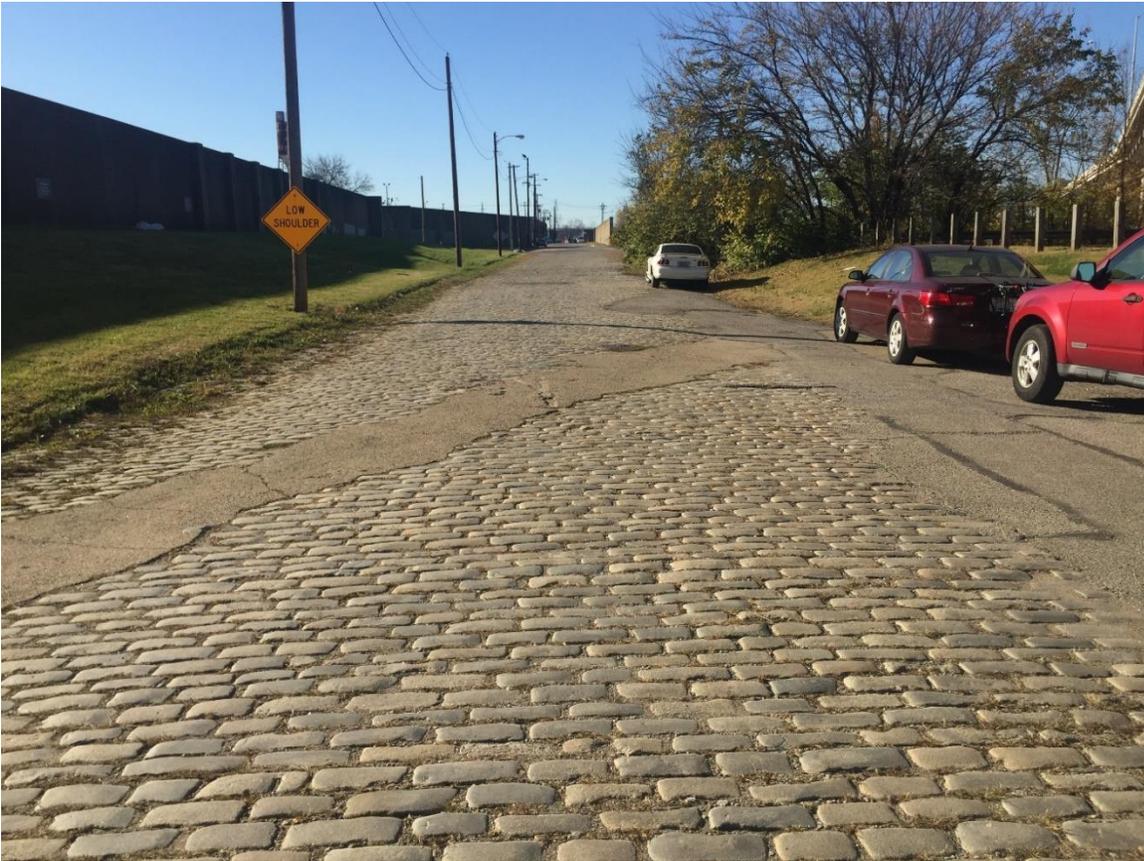
**Figure 69. Earlier trench cut across Rowan Street.**

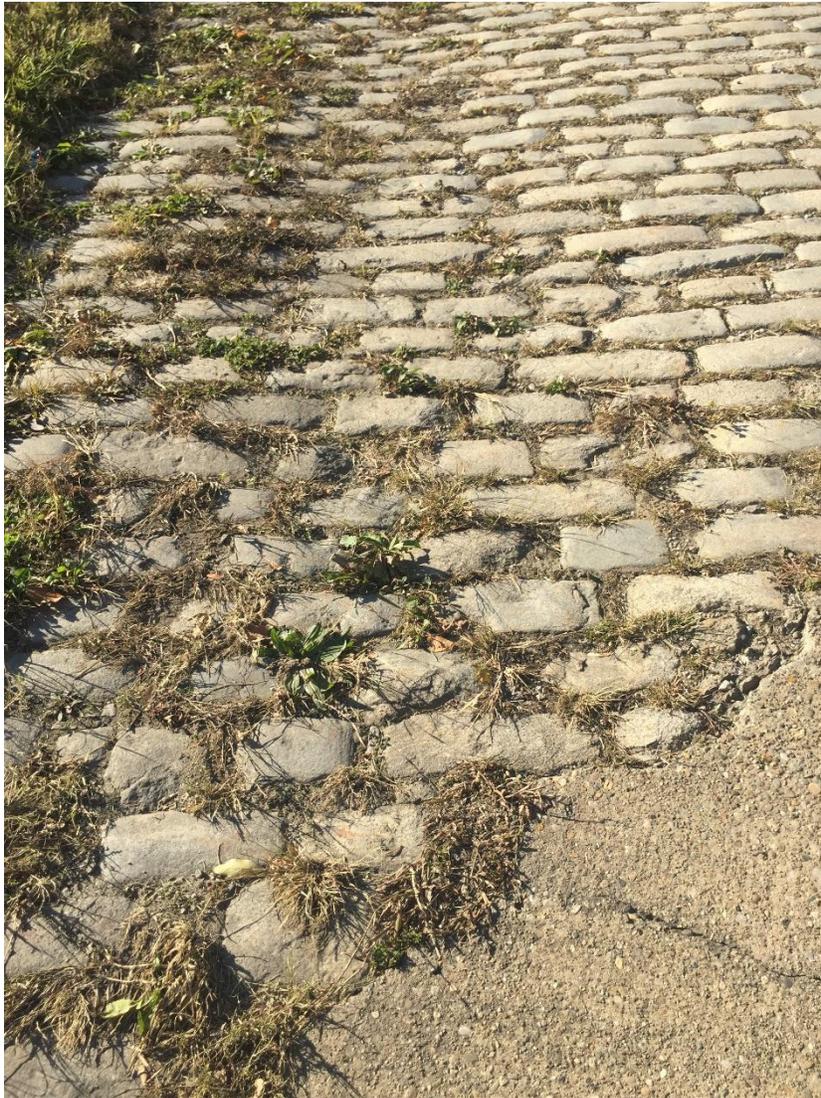
**Figure 70. Uneven surface of some parts of pavement.**

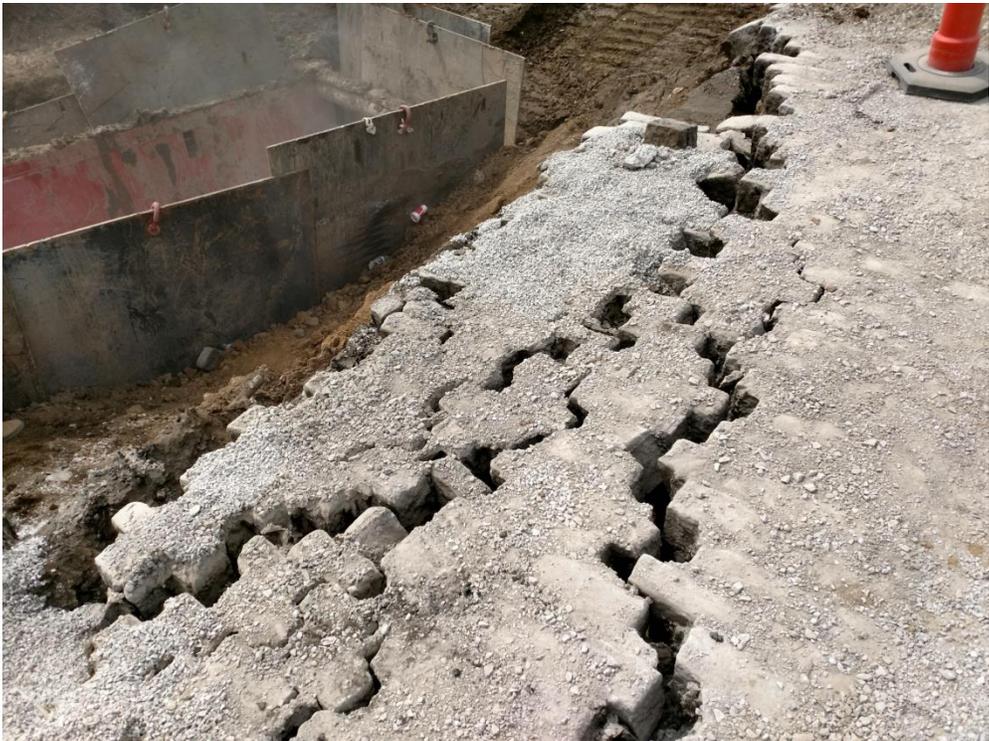
**Figure 74. Fractures and subsidence along the trench edge, facing southwest.**

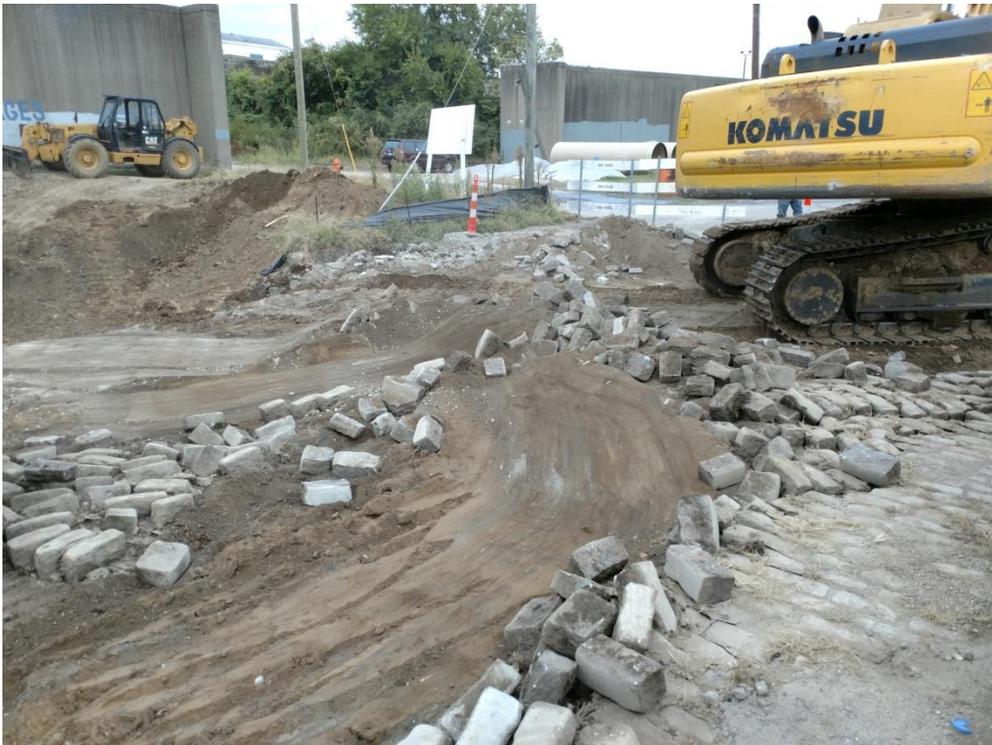
**Figure 75. Boulder block removal in progress, facing southwest.**

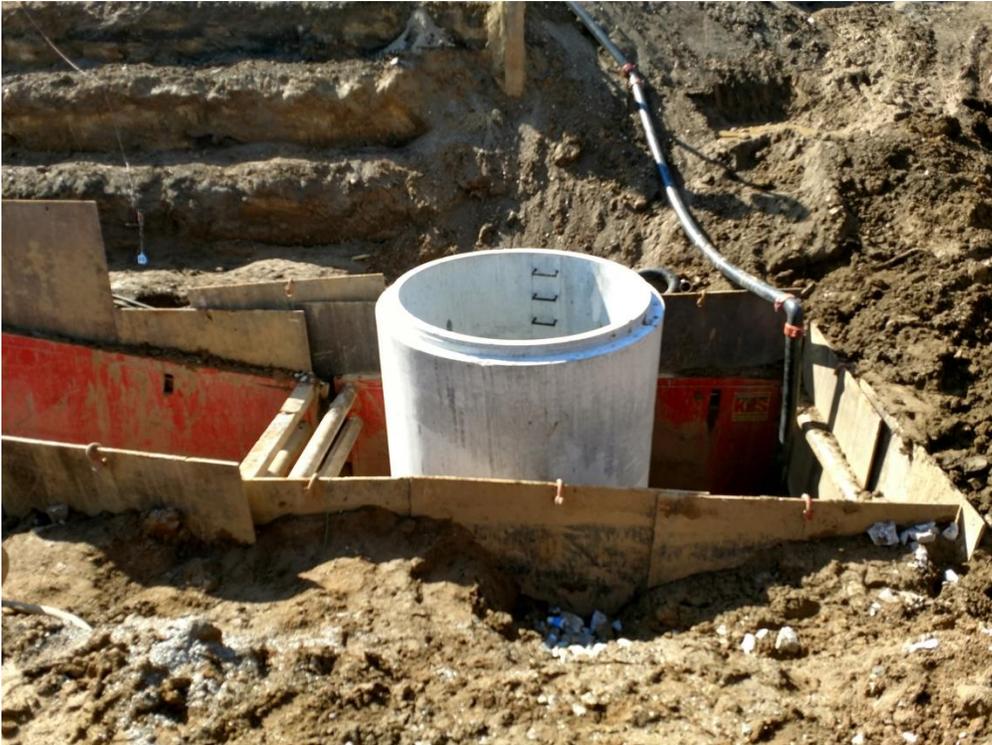
**Figure 76. Vertical concrete manhole, facing south.**

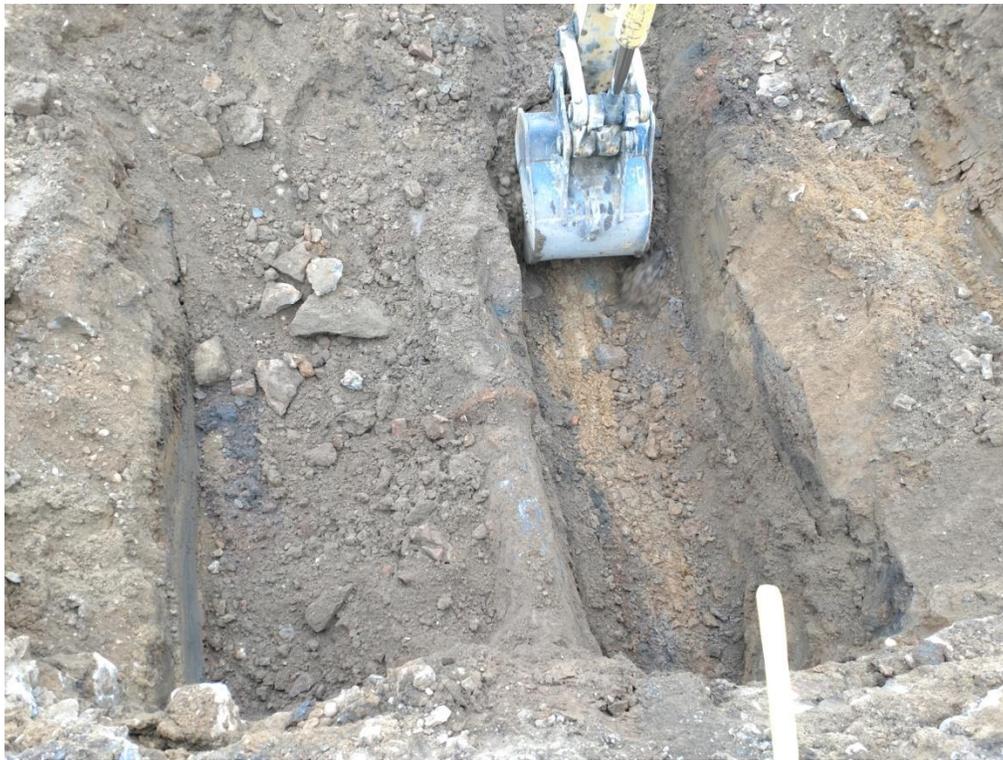
**Figure 77. Excavation underway to expose water main for capping and removal, facing east.**

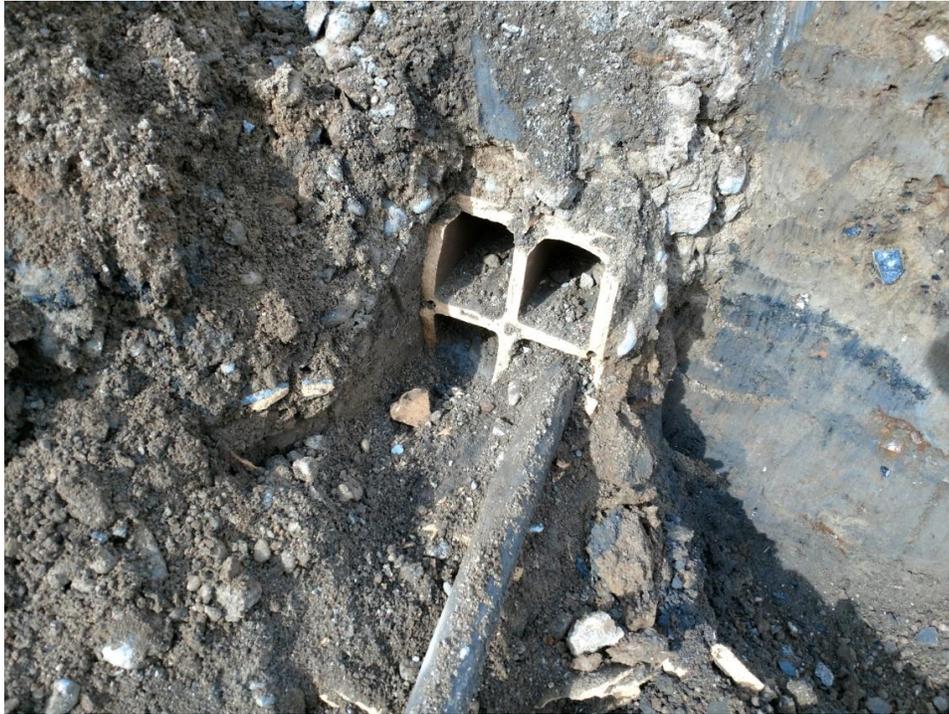
**Figure 78. Ceramic tile conduit for abandoned phone cable, facing west.**

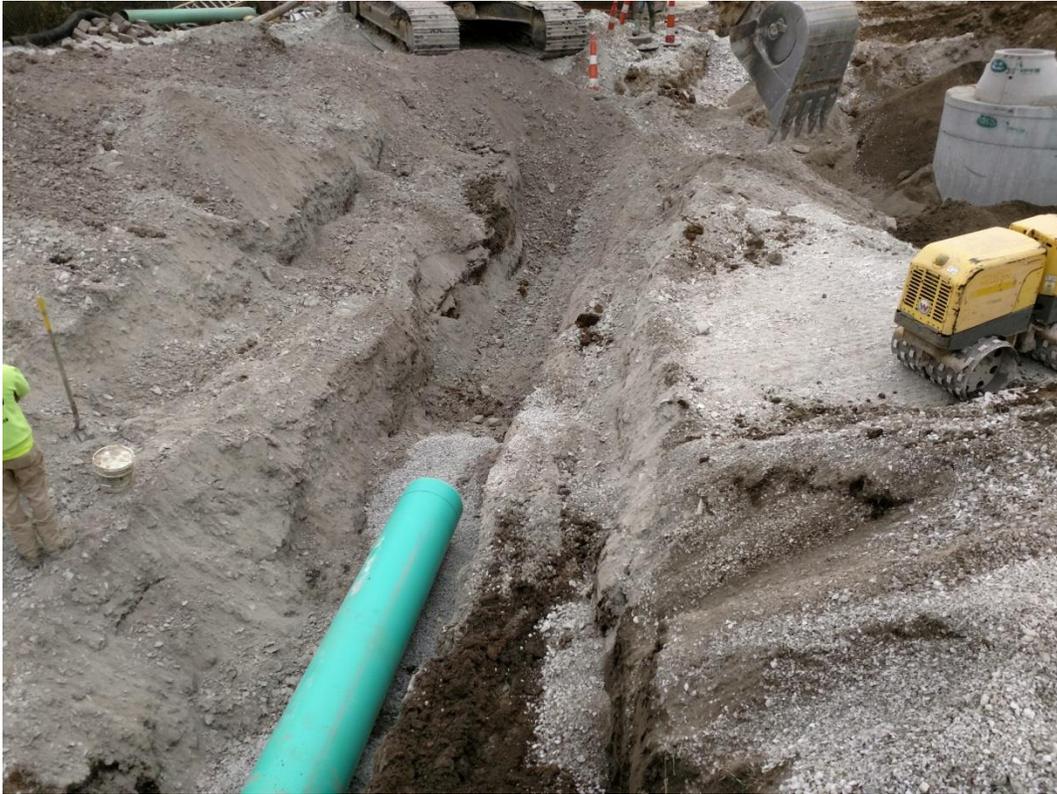
**Figure 80. Original sewer line replacement underway, showing shot rock and gravel backfill, facing east.**

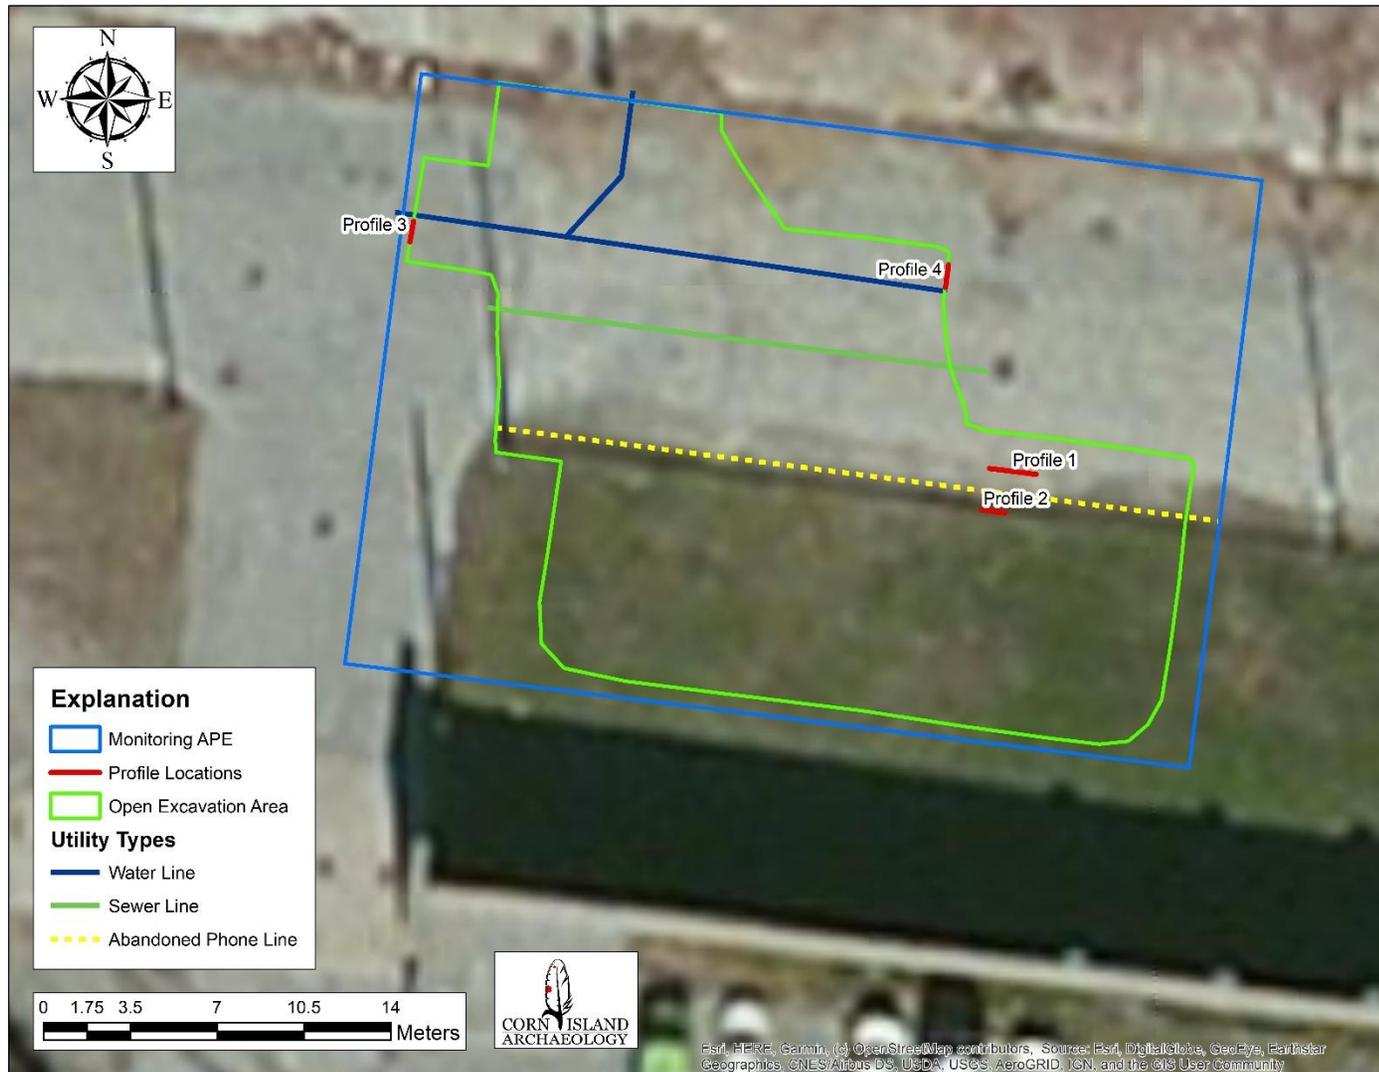
Figure 81. Project area showing excavation boundary, profile locations, and various utility disturbances.

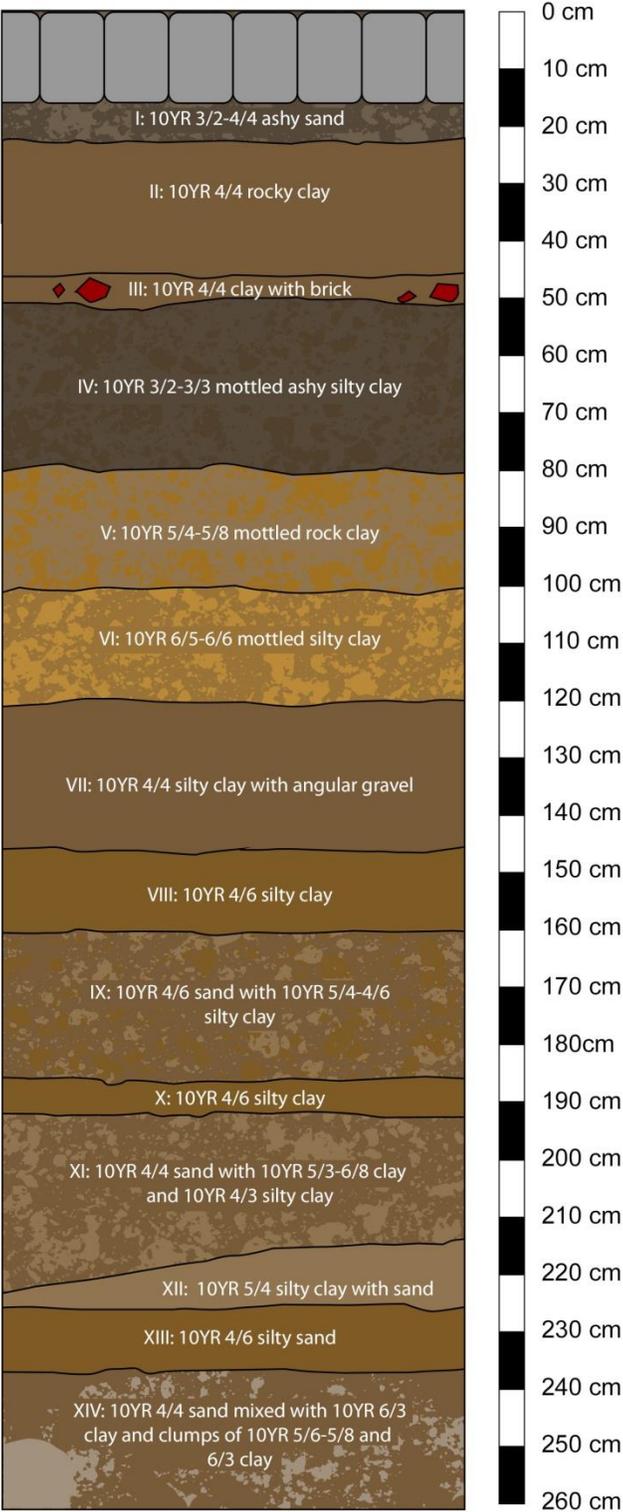
Figure 84. Profiles 1 and 2 combined, facing north toward Rowan Street.

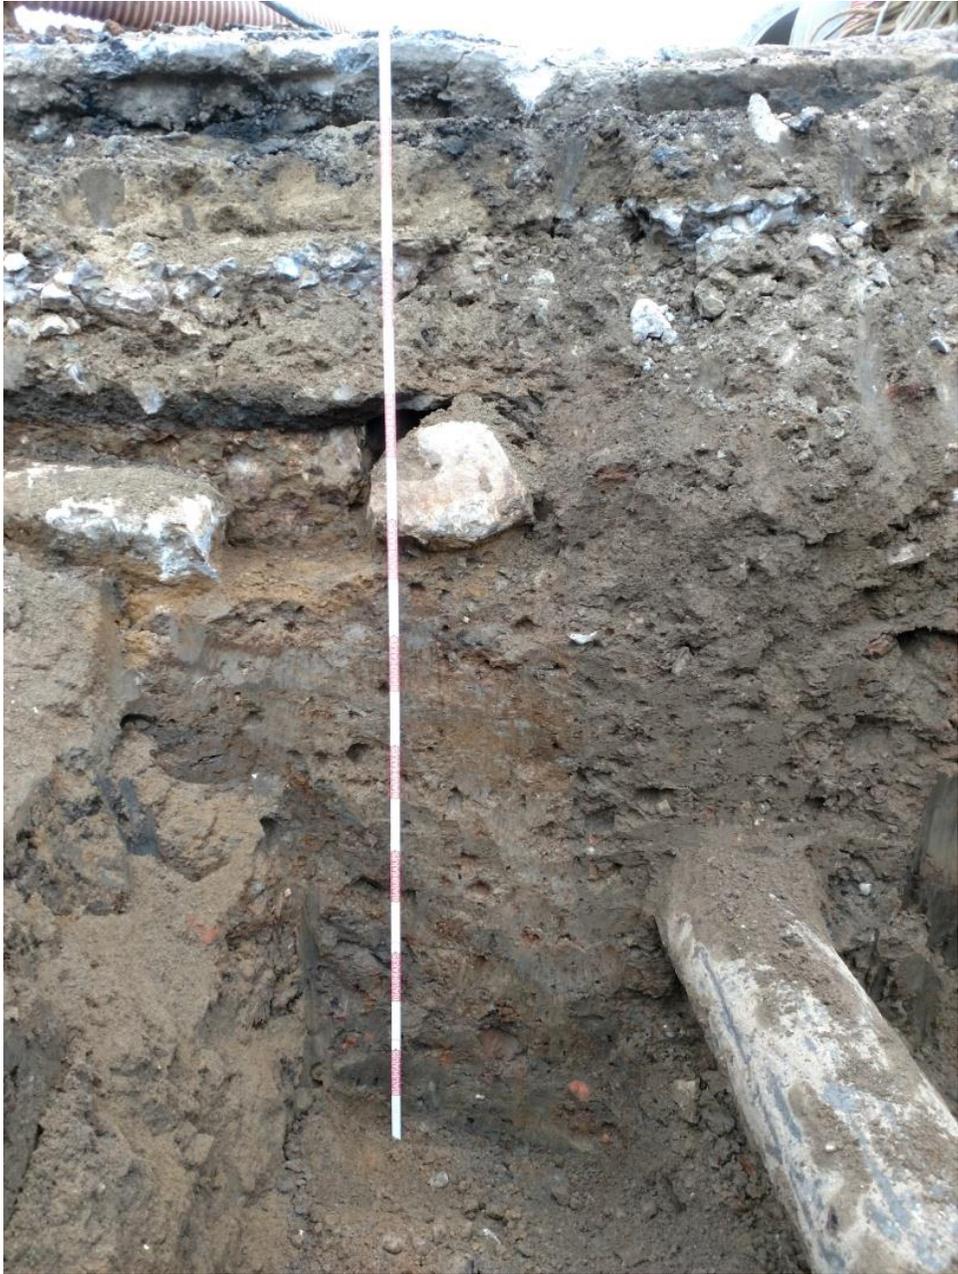
**Figure 85. Profile 3 at the western end of the water main removal trench.**

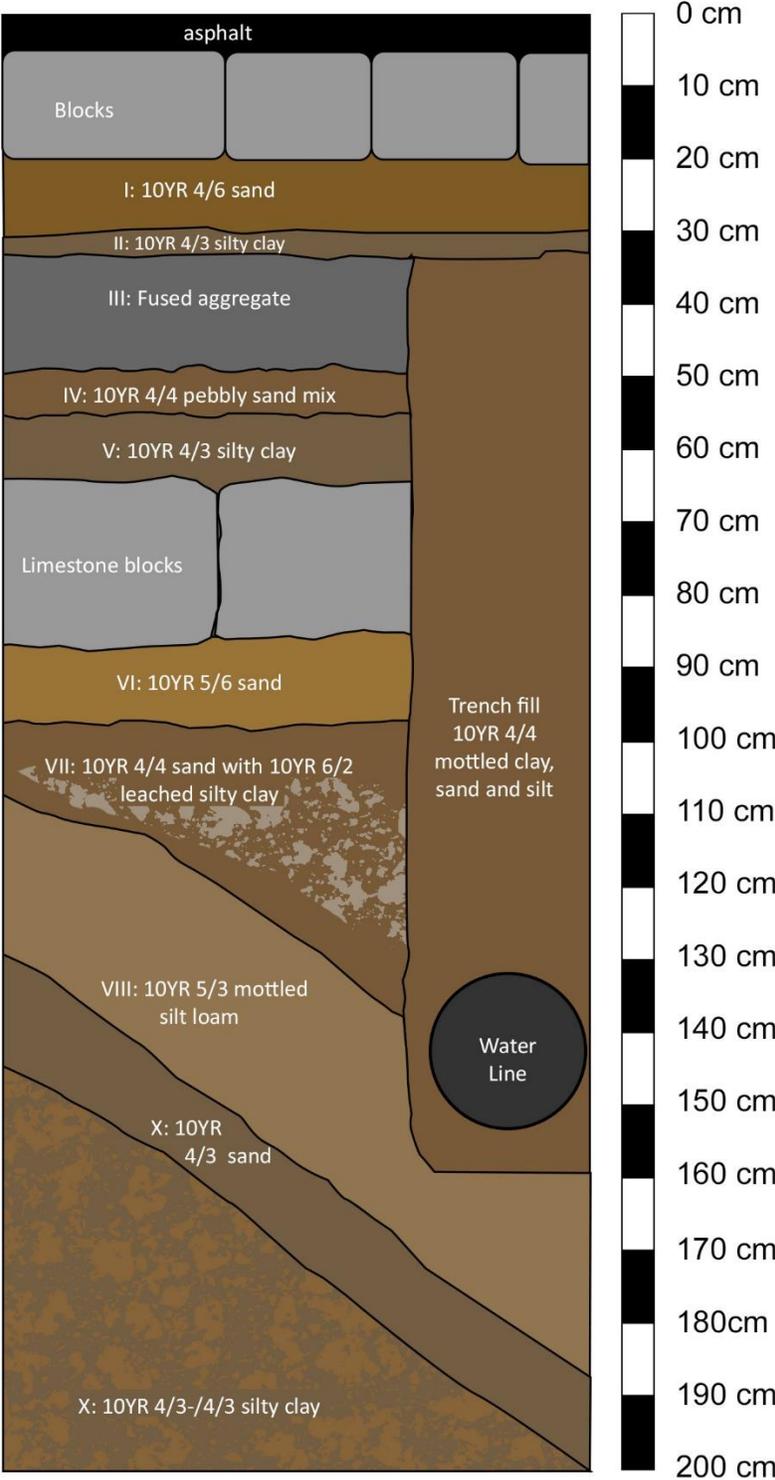
**Figure 86. Graphic representation of Profile 3 at the western end of the water main removal trench.**

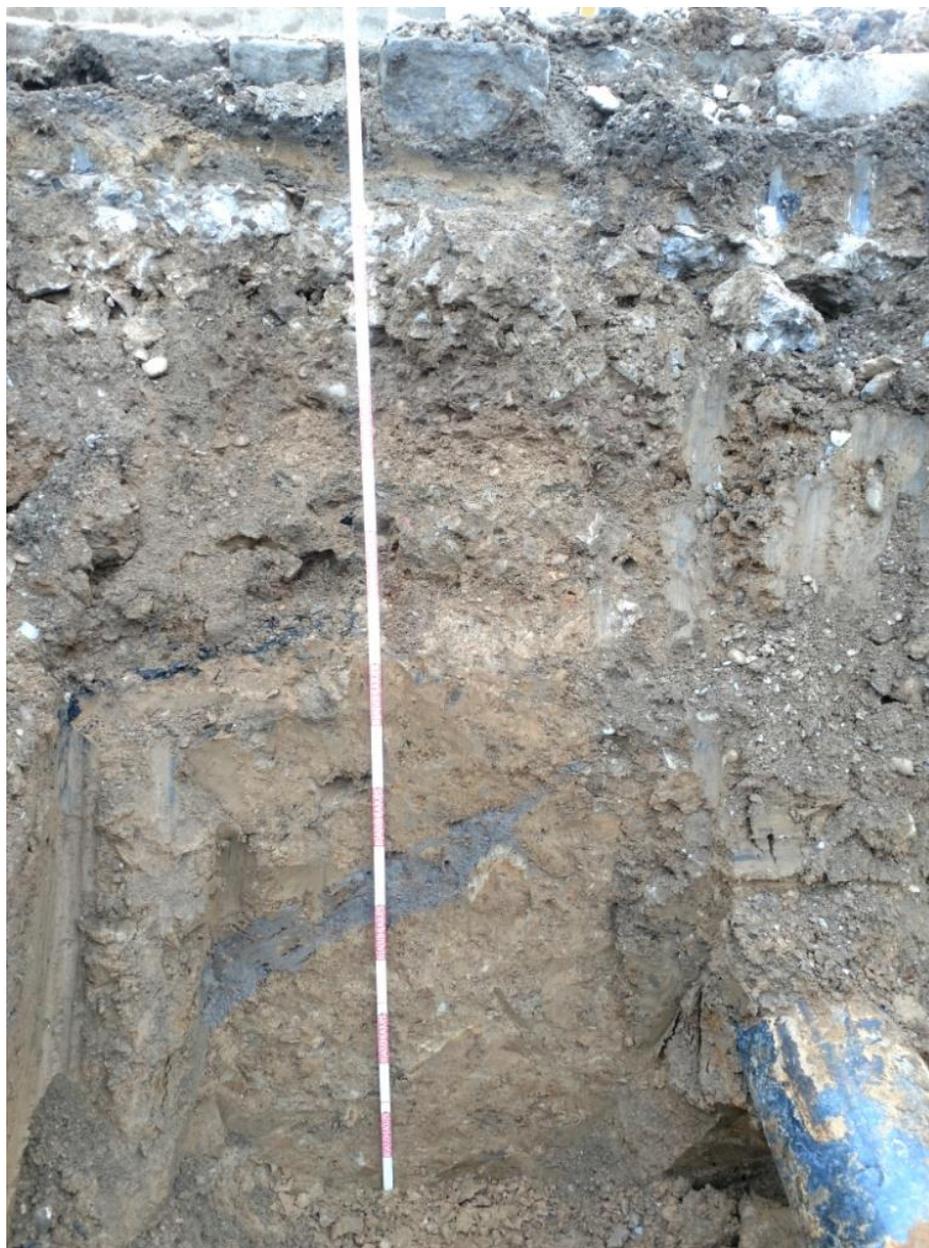
**Figure 87. Profile 4 at the eastern end of the water main removal trench.**

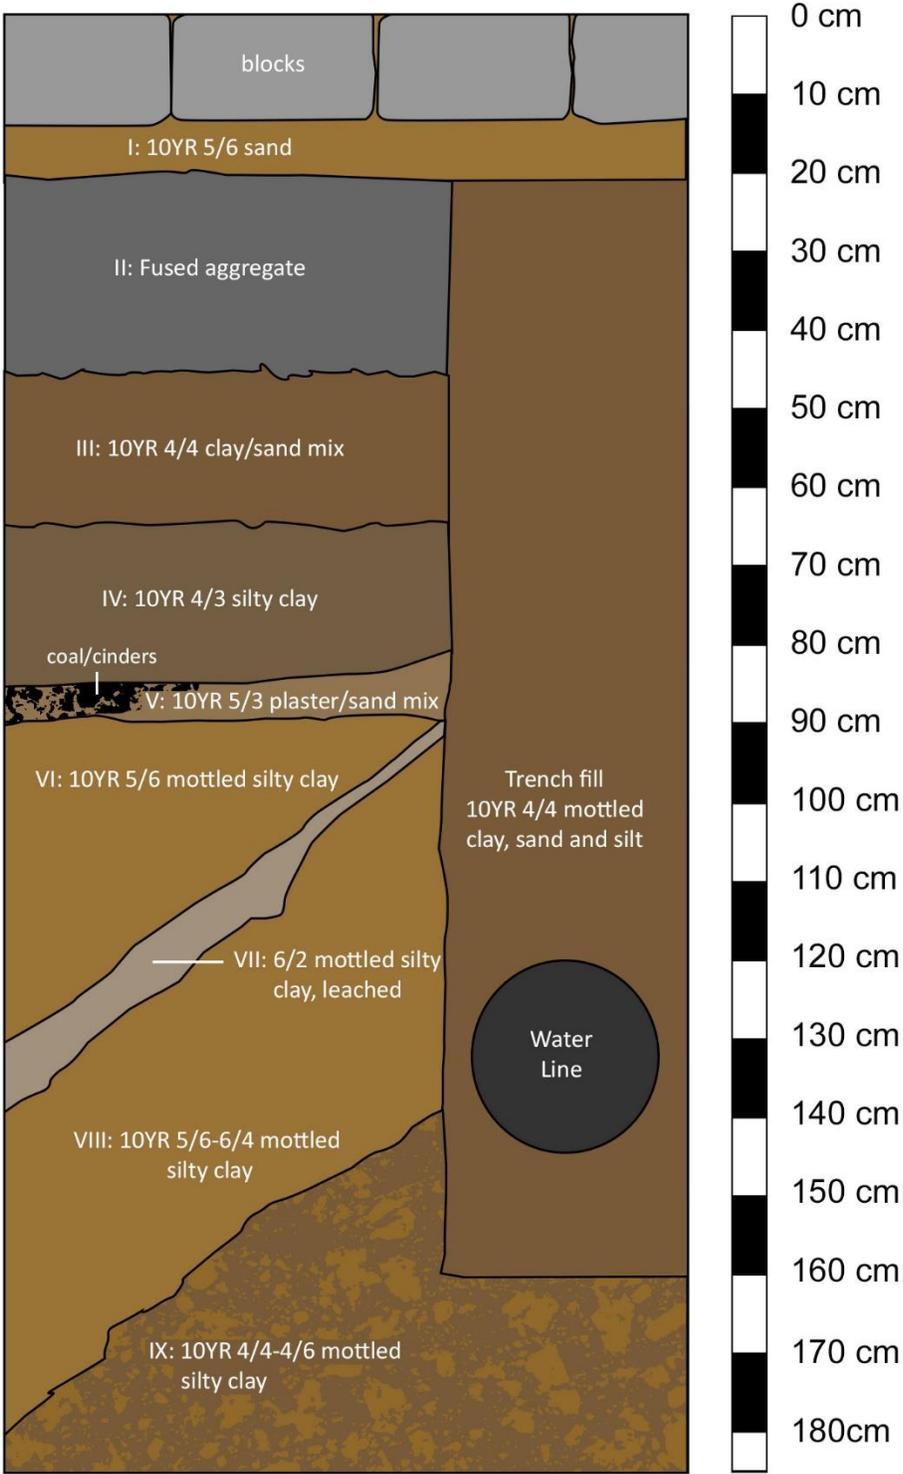
Figure 88. Graphic representation of Profile 4 at the western end of the water main removal trench.

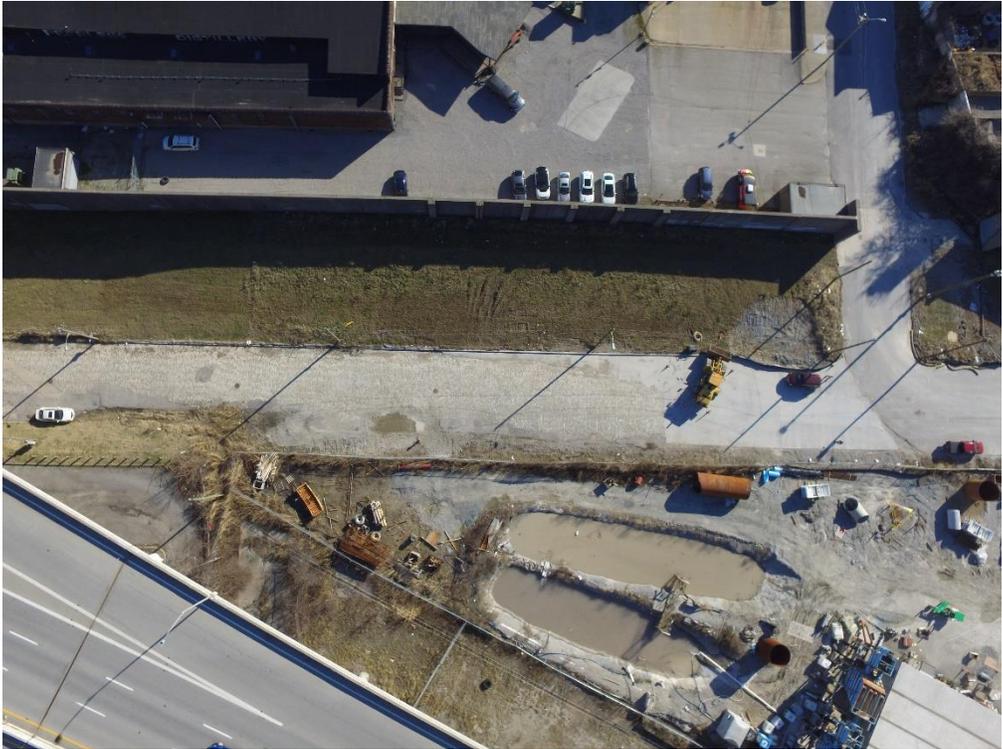
**Figure 93. Extant portion of Rowan Street boulder block pavers facing south.**

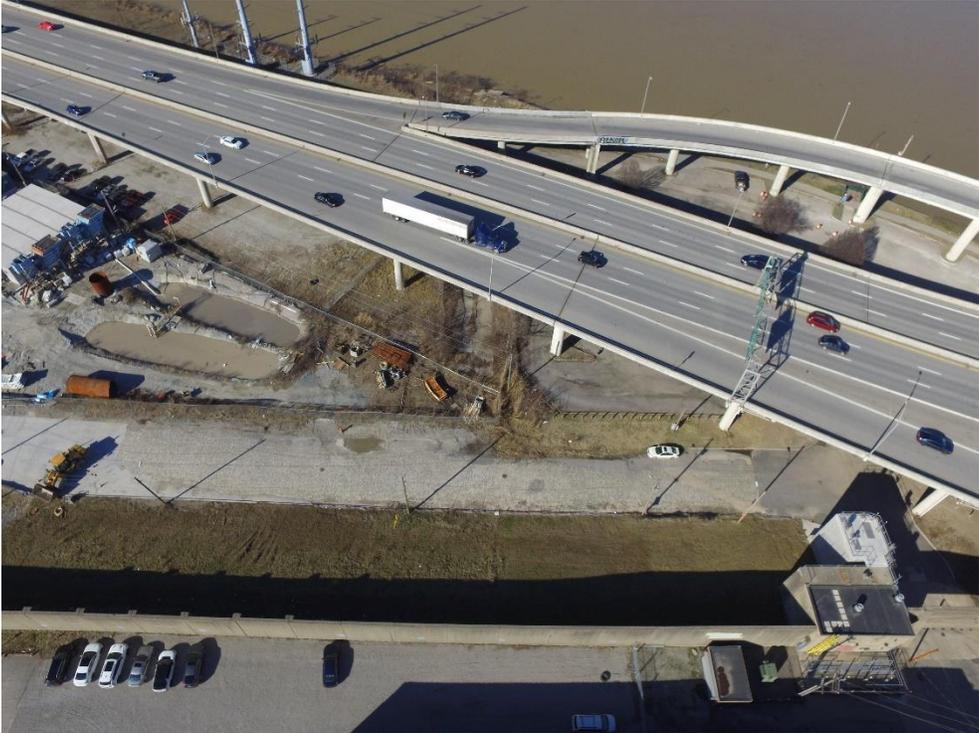
**Figure 94. Extant portion of Rowan Street boulder block pavers facing north.**
